2024 Aquatic Plant Survey and Invasive Species Detection Report Round Lake near Nisswa

Prepared for the Round Lake Association

Survey by Aquatic Survey Professionals – MN DNR Certified Aquatic Plant Surveyors

Survey Dates June 14th 2024

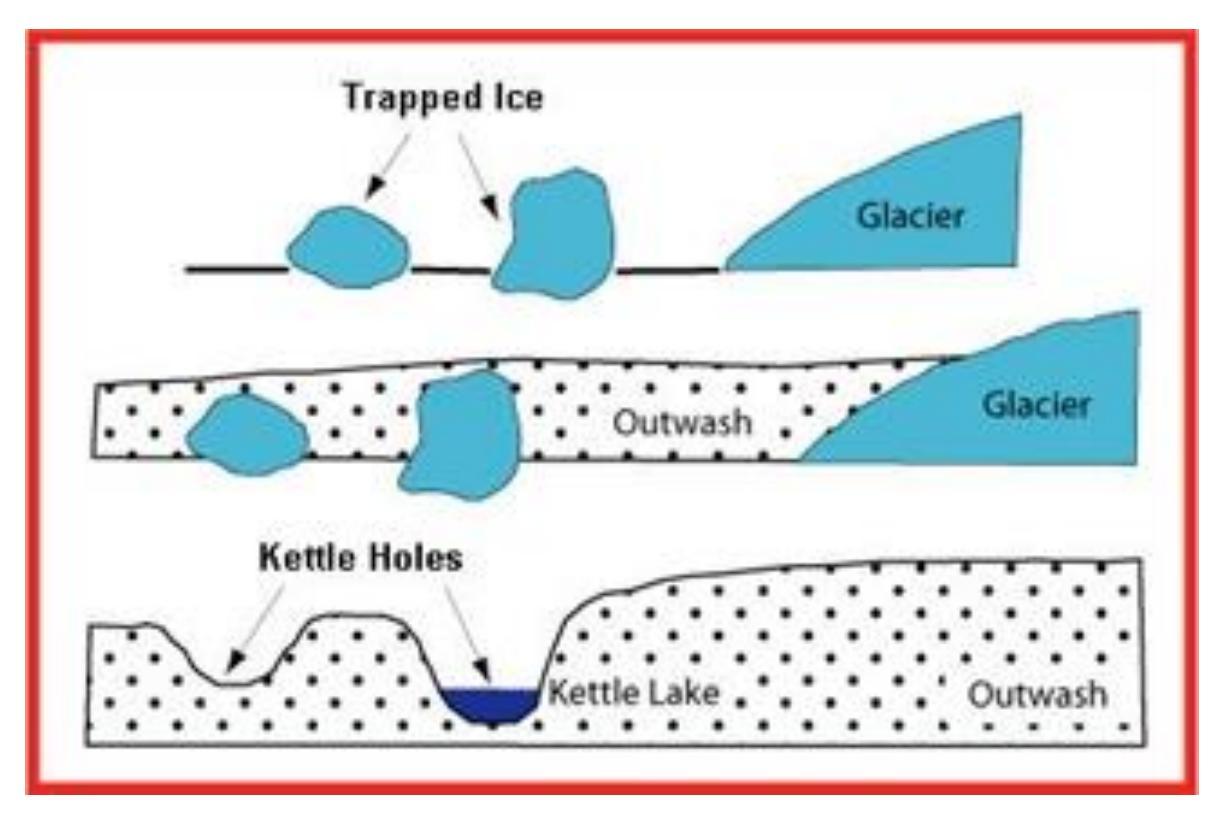
Sketch of a how kettle lakes are formed in outwash areas.

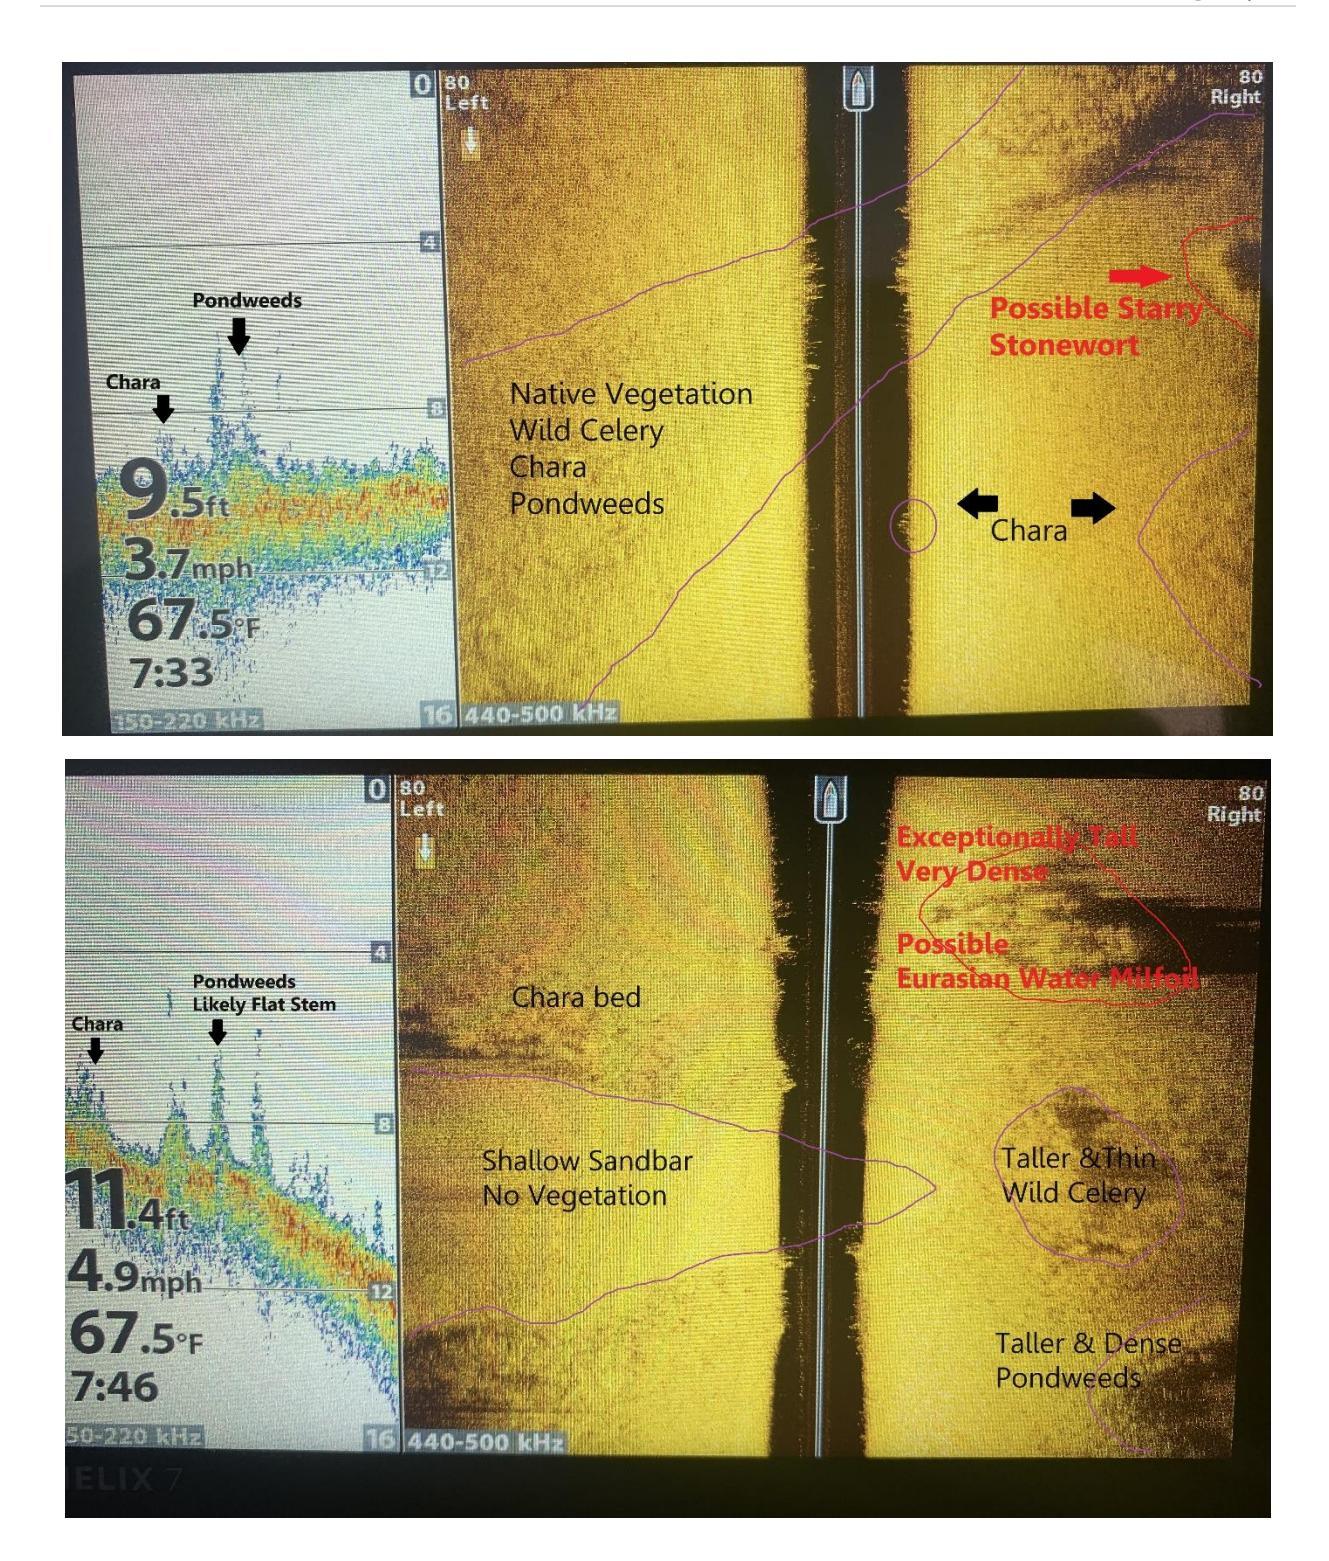
These images were produced with side scan set to 80 feet allowing the surveyor to see that far to each side of the boat track. The black area represents the water below the boat, the black area is equal to the water depth. Sample waypoints can be dropped on this screen to mark suspicious sites. Those waypoints are correctly offset to the side and behind the boat exactly on top of the suspicious growth allowing the surveyor to navigate back for additional sampling.

Side scanning sonar covers both sides of the boat track and has an adjustable scan width. Up to 200 feet in each direction can be displayed on the sonar unit which covers a track width of 400 feet. Normally the side scanning is set closer to 100 feet to keep the image clarity high, this increases the survey coverage from one small point every 200 feet to a continuous swath of observations 200 feet wide tracking back and forth across the lake. Combined with visual observations made continuously as the boat tracks the lake the 'density' of observations sky rockets compared with traditional point surveys. See the example images on the next page.
